Fire Risk Assessment Report

Company / Organisation	St Augustine's Priory Main school
Site Address	Hillcrest Rd, London W5 2JL
Contact Details	Bursar J Powell Switchboard: 020 8997 2022 Direct Line: 020 8991 7514 www.sapriory.com
Photograph of Site

As part of the service to St Augustine's Priory (Main school) Jo Banks of Arinite conducted a comprehensive inspection and subsequent fire safety risk assessment of the main school building and Chapel on 8th October 2019

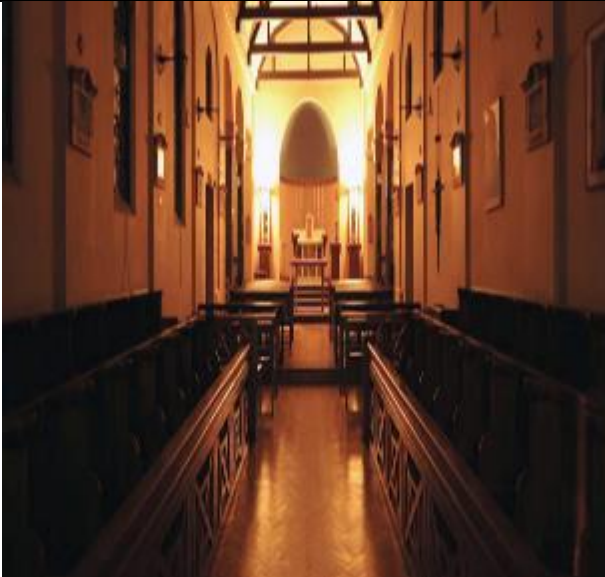
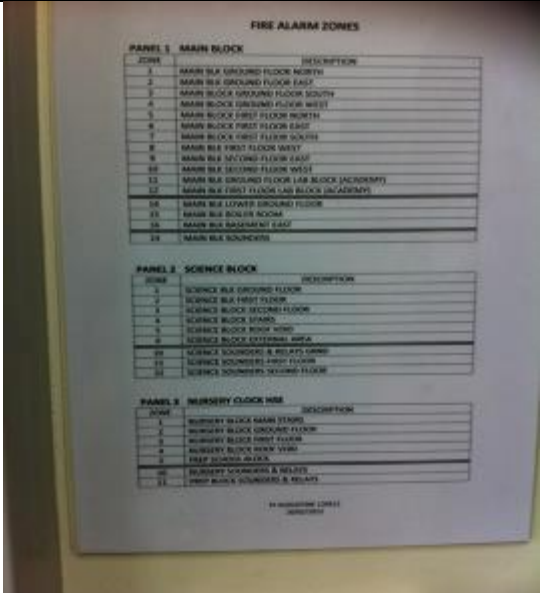
ZONE	DESCRIPTION																																																																																										
1	MAIN BLOCK GROUND FLOOR NORTH																																																																																										
2	MAIN BLOCK GROUND FLOOR EAST																																																																																										
3	MAIN BLOCK GROUND FLOOR SOUTH																																																																																										
4	MAIN BLOCK GROUND FLOOR WEST																																																																																										
5	MAIN BLOCK FIRST FLOOR NORTH																																																																																										
6	MAIN BLOCK FIRST FLOOR EAST																																																																																										
7	MAIN BLOCK FIRST FLOOR SOUTH
