Fire Risk Assessment Report

Company / Organisation	St Augustine's Priory Main school
Site Address	Hillcrest Rd, London W5 2JL
Contact Details	Bursar J Powell Switchboard: 020 8997 2022 Direct Line: 020 8991 7514 www.sapriory.com
Photograph of Site

As part of the service to St Augustine’s Priory (Main school) Jo Banks of Arinite conducted a comprehensive inspection and subsequent fire safety risk assessment of the main school building and Chapel on 8th October 2019

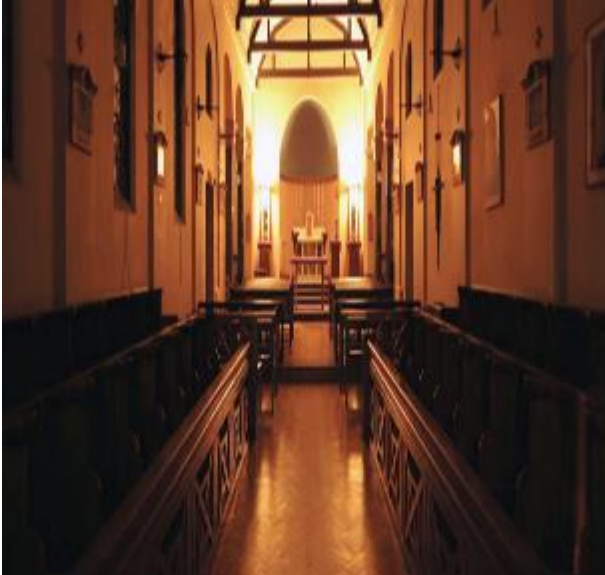
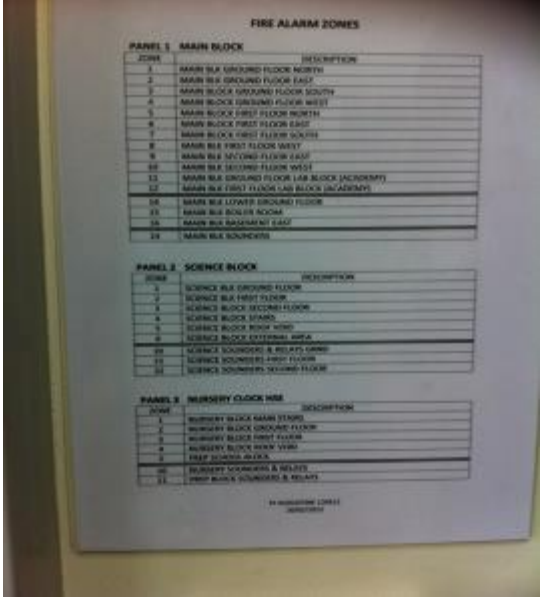
<table><tr> <th colspan="2">FIRE ALARM ZONES</th> </tr></table>

<table><tr> <th colspan="2">FIRE ALARM ZONES</th> </tr><tr> <td colspan="2">PANEL 1 MAIN BLOCK</td> </tr><tr> <th>ZONE</th> <th>DESCRIPTION</th> </tr><tr> <td>1</td> <td>MAIN BLK UPPER FLOOR NORTH</td> </tr></table>
