Fire Risk Assessment Report

Company / Organisation	St Augustine's Priory Science Block
Site Address	Hillcrest Rd, London W5 2JL
Contact Details	Bursar J Powell Switchboard: 020 8997 2022 Direct Line: 020 8991 7514 www.sapriory.com
Photograph of Site

As part of the service to St Augustine's Priory (Science Block) Jo Banks of Arinite conducted a comprehensive inspection and subsequent fire safety risk assessment of the Science Block building on 8th October 2019

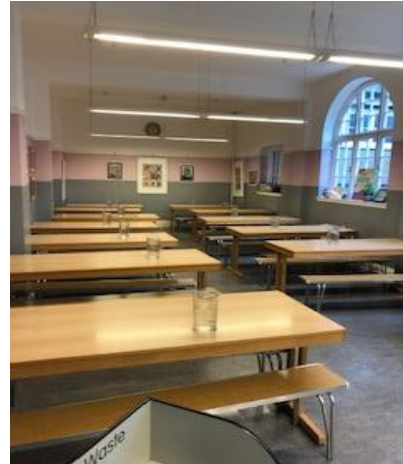
2. Dining Room

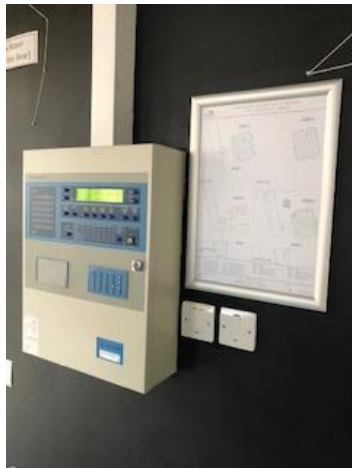
Ref.	Hazard	Y/N/NA	Comment / Photo Ref. No.
6.2	Is the fire alarm control panel (or any repeater panel) conveniently located for fire service access, complete with a zone diagram?	Y	Own panel in lobby, site manager and contractor manages fire alarm system for building.

3. Fire panel in lobby science Block

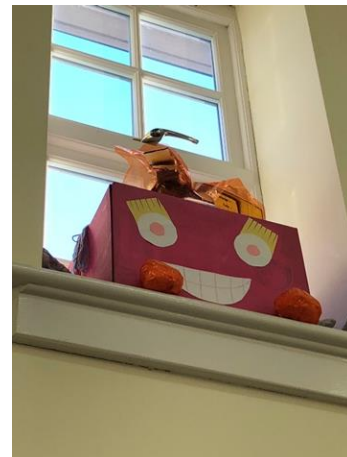
Ref.	Hazard	Y/N/NA	Comment / Photo Ref. No.
9.12	Have reasonable measures been taken to prevent the spread of fire in respect of the surface linings, decorations of walls and ceilings, and/or floor coverings?	N	Some flammable art works. See pictures Action raised.

4. Paper models in fire escape route

Ref-Date	Subject (Section)	Fire Hazard	Risk	Persons at Risk	Priority	Action Required	Target Date	Completed
01-10-19	Electricity	No evidence of 5-year Electrical Installation condition report certificate. However, Maintenance manager was available and indicated the test was completed for all areas and certification held. Due to re-test in 2022/2023 multiple areas.	Fire starting Ignition source	All	L	Check certificate for any defects or actions to resolve from last inspections.	1 month	
02-10-19	Ignition Source	Pat Testing incomplete Electrical safety	Source of ignition faulty wiring or appliance	All	L	All equipment was subject to a maintenance programme, including portable electrical appliances which were tested by employees. This program had fallen behind schedule.	2 months	
03-10-19	Means of Escape	Art works and paper sculptures in escape routes.	Failure to escape	All	M	Remove flammable items from main escape routes.	2 months

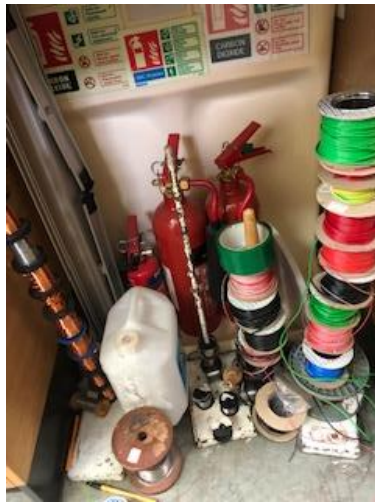
3.2	Do housekeeping standards minimise the risk of accumulation of combustible materials?	Y	Some clutter in storeroom.
3.3	Are combustible materials stored to minimise their potential for contact with sources of ignition?	Y	Teachers have been advised about clutter, storage areas and decorating corridors and classrooms.

5. Clutter in Science store
